Biomonitoring research on persistent organic pollutants in the environment surrounding the cement plant

Turňa nad Bodvou, Slovakia | 2023

Report

PUBLICATION NUMBER: 2024-SK-01

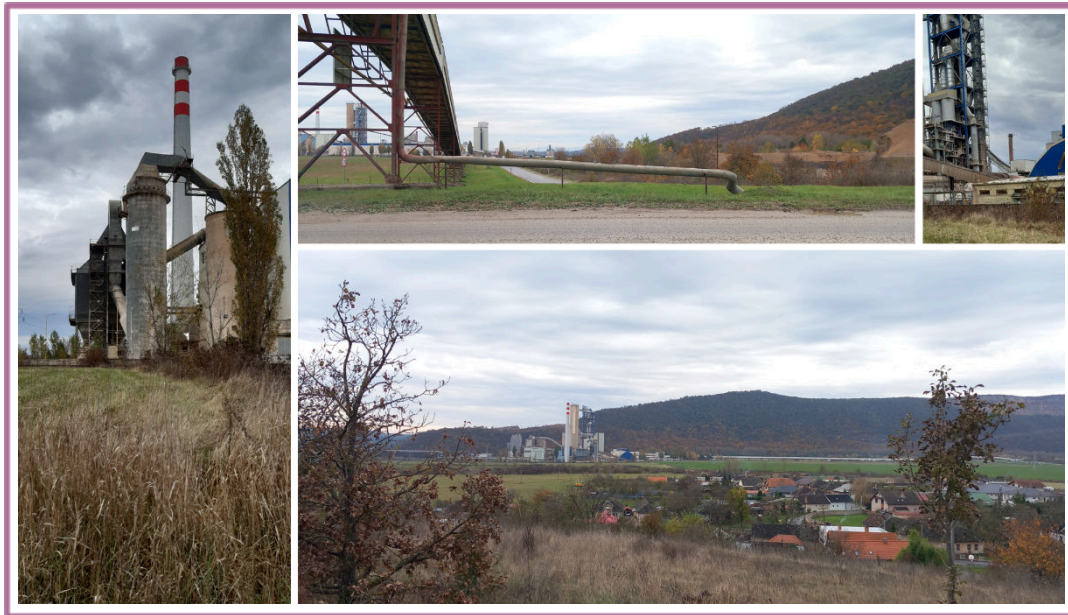
Figure 1 - The cement kiln Turňa nad Bodvou

According to the Turňa nad Bodvou Cement Plant's website,¹ the plant is equipped with state-of-the-art BAT/BREV equipment. Waste gases with a volume flow rate of 165000 m³/hour are discharged into the air through a fabric filter and, subsequently, through a chimney with a height of 51.0 meters. The dust separated by the fibre filters is transported as dried clay to the raw material landfill. The conveyor belts used for transporting the clay for crushing within the plant to the sieving station are dust-tight.² Cement production ranks among the energy-intensive industries. This plant, which is supported by EU grants, burns waste materials, ranging from plastic agglomerate, worn-out old used car tyres, and PCB oil-containing waste³ - as a sustainable alternative to fossil fuels. There are plans to increase waste burning from 65,000 to 115,000 tons annually - a nearly 50% increase. Cement kilns are utilised to destroy persistent organic pollutants such as PCBs and PFAS, owing to the higher combustion temperatures they provide.
